EVA

April 2005

Signal System Report

Lyndo Tippet, Secretary
Rail Division, North Carolina Department of Transportation

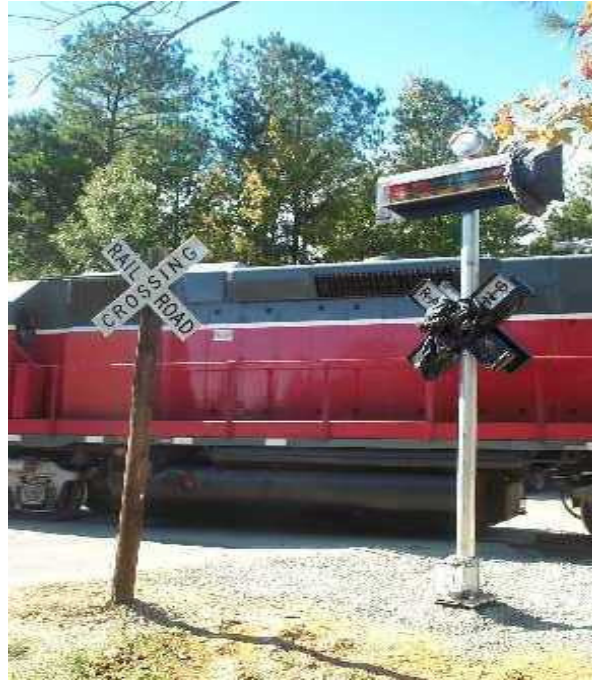
Figure 3.1 – EVA Signal System

The visual warning provided to the highway user is accomplished through the use of a standard crossbuck but with the addition of 336 kilo bright light emitting diode (LED) strips aligned atop the crossbuck and forming a large “X” when activated. The red kilo bright LED lights are highly visible during the daylight and evening hours. The stated life expectancy of these lights is around 100,000 hours although during the test, some bulbs failed within three (3) months. The LED strips are protected from vandalism by a covering of ½ inch LEXAN[®] covering the entire face portion of the crossbuck.

The EVA Signal System provides a much more dynamic warning than traditional signal systems. A flashing LED array in an “X” pattern enhances the standard reflectorized crossbuck, and the flashing strobe bar provides additional clarity. The direction of approach of a train is indicated by the TDA, which consists of six yellow halogen lights sequentially activated to indicate the direction of approach.

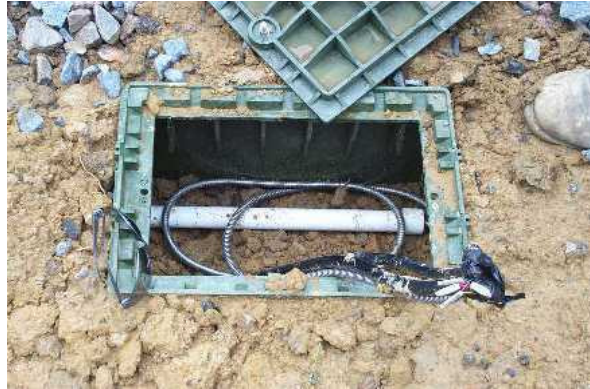
Figure 3.2 – Installed Magnetometer

The EVA Signal System’s Off-Track Train Detection System detects trains by means of six magnetometer sensors on each approach and buried in the right of way. The first and second magnetometers calculate the speed of the train, train movement is verified at the fourth probe and island type activation is performed by the sixth probe. The third and fifth probes function in back up mode which occurs for five minutes after an activation caused by the other four probes. Magnetometers sense changes in the ambient magnetic field such as the changes caused by the large mass of iron of an approaching train. A

series of sensors placed along the track allows estimation of both the location of the approaching train and its speed. This enables the provision of approximately constant warning time for motorists and pedestrians near the crossing. In addition, the EVA system confirms the presence of the train at the crossing with a set of infrared (IR) detectors mounted on steel posts at the crossing. The IR detectors are positioned to direct beams across the tracks diagonally from one quadrant of the crossing to the opposite quadrant. A train on the track interrupts the IR beams, ensuring that the system continues to detect the train's presence.

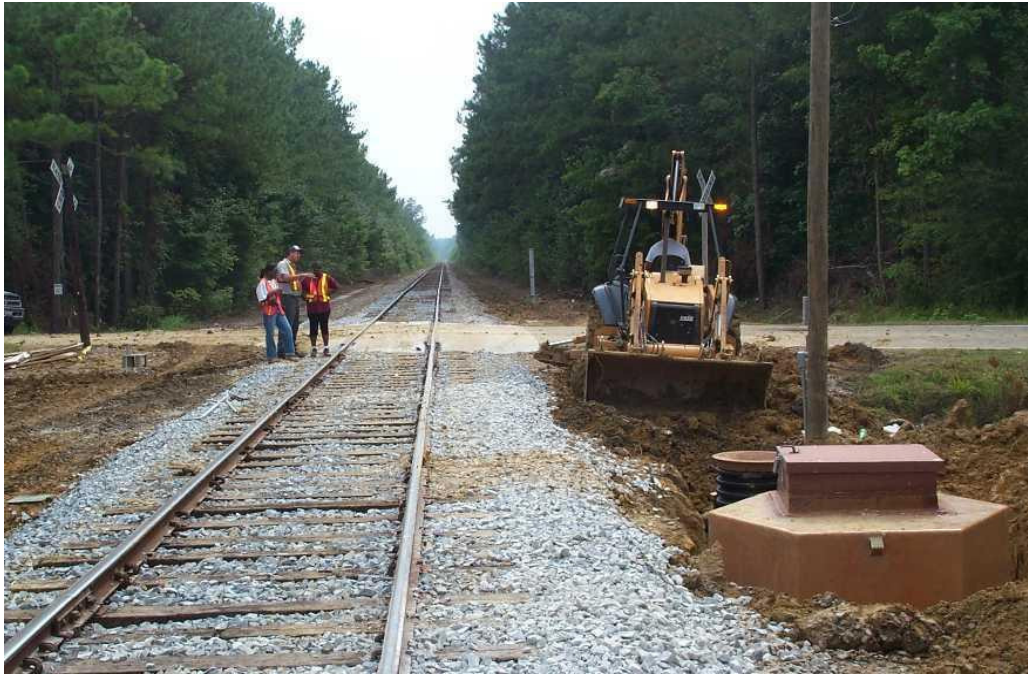
Figure 3.3 – Vault filling

One disadvantage was quickly discovered when the underground vault flooded from the conduit feeding it and eventually caused officials to reinstall the equipment cabinet above ground.

The underground vault had a number of advantages over conventional above ground containment. It provided a controlled environment for the solid state components used by the main processor. Moreover, its location was out of harms way from automobiles, etc., which might diverge from the roadway.
